**Flood Control Project Maintenance
Levee Inspections**

Fall 2018 Levee Maintenance Deficiency Summary Report

**Flood Control Project Maintenance
Levee Inspections****LMA District Cover Sheet
Fall 2018 Levee Inspection Results****Knights Landing Ridge Drainage District**

Knights Landing Ridge Drainage District

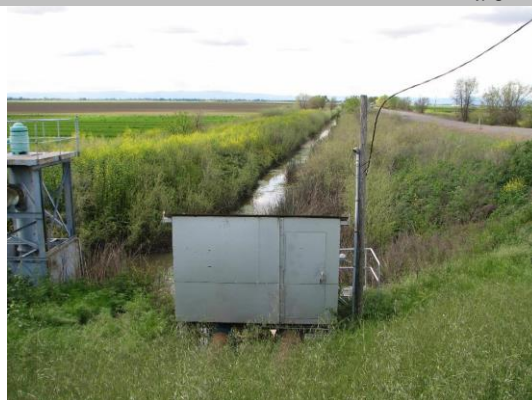
Photo 1 of 3 : UCIP_FA_2018_16106_27213.jpg

Pumphouse and pipe on LS toe.

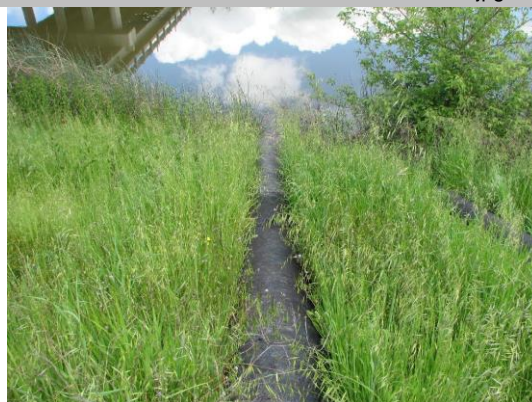
Photo 3 of 3 : UCIP_FA_2018_16106_27214.jpg

Pipe on WS slope.

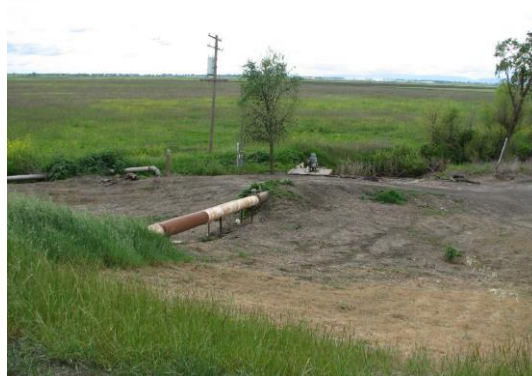
Photo 1 of 3 : UCIP_FA_2018_11264_18622.jpg

LM Start	4.89	Rating **	M	Issue No.	41
LM End	4.89	Issue Type +	En	Location *	
Category	Supplemental			GPS Latitude/Longitude	
				Start	End
Item	DWR UCIP Field Study			38.777566 °	38.777566 °
				-121.707591 °	-121.707591 °
DWR ID	19367				
Comment Code					
Inspector Comment					
FS_ID:11264 DS_ID:19367 EP_NO: 4443 Repair Type: Non-Urgent Crossing Status: Found UCIP Comments: Pipe does not have adequate cover at crown. FIELD_STRUCT_DESC: 16-inch steel drainage pipe through the levee, 0.5 feet below the crown. Pad constructed over pipe for vehicular crossing. Pump on metal structure on the landside (LS). Flap gate on the waterside (WS) end. Siphon breaker on the pipe on the WS. Slide gate on the LS toe. (Permit No. 4443, 1963 - Reclamation District No. 730). Design drawings available in permit. [Additional Reference(s): DWR Levee Log, 1990]. FS Date: 4/5/2013

Pump and pipe on LS toe.

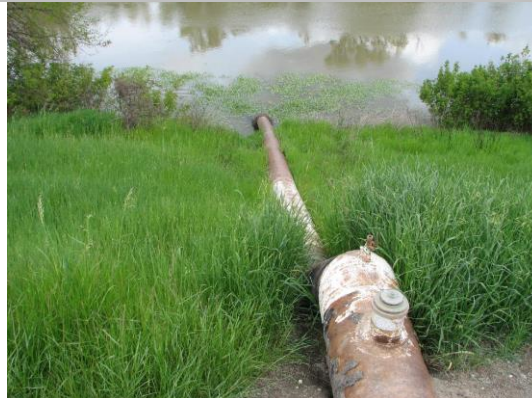
Photo 2 of 3 : UCIP_FA_2018_11264_18621.jpg

Siphon and air vent on WS shoulder.

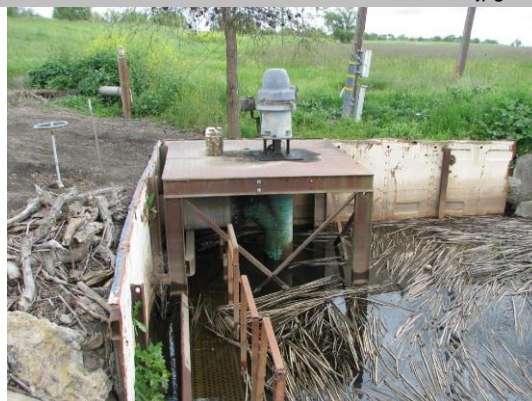
Photo 3 of 3 : UCIP_FA_2018_11264_18620.jpg

Pump on Steel pile structure with slide gate at LS toe.

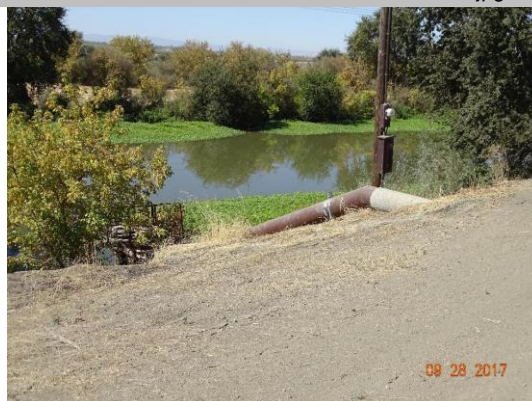
Photo 3 of 3 : UCIP_FA_2018_52536_77500.jpg

Comment Code						
Inspector Comment						
FS_ID:52536 DS_ID:19370 EP_NO: 9320 Repair Type: Non-Urgent Crossing Status: Found UCIP Comments: 09/27/2017 Received updated information from DWR levee inspector, Zachary Jojola, confirming that this crossing is still abandoned. Recommend pipe be abandoned properly according to Title 23 requirements. Updated photos have been added to this report. (DWR UCIP - O. Magana)04/09/2013 Appears abandoned as pump is missing from platform. (DWR UCIP - W. Wylie) FIELD_STRUCT_DESC: 16-inch steel irrigation pipe through the levee, 2.8 feet below the crown. Pipe discharges into a 36-inch concrete standpipe at the levee toe. Pump on steel pile structure in stream with metal walkway. Two service poles on the waterside (WS) slope. (Automatic Board Order (ABO) issued as Permit No. 9320, 1974 - Ralph W. Pollock). [Additional Reference(s): DWR Levee Log, 1990. USACE Sacramento O&M Manual 127, June 1953, (Station 52+00) (15-inch pipe listed)]. FS Date: 11/29/2017 12:46:36 PM

WS view: pipe and electrical panel visible.

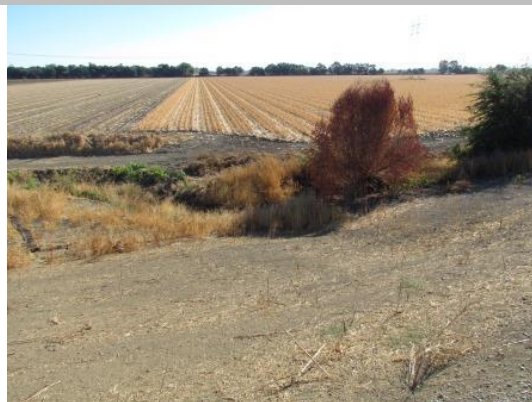
Photo 1 of 1 : FA_2018_NA0008_257_22_20180904_00006.jpg

LM Start	1.34	Rating **	M	Issue No.	22
LM End	1.54	Issue Type +	En	Location *	LS
Category	Earthen Levee			GPS Latitude/Longitude	
				Start	End
Item	Encroachments			38.737214 °	38.739591 °
				-121.683159 °	-121.685327 °
DWR ID	DWR_NA0008_02_f_2016_22				
Comment Code					
DT : Ditch					
Inspector Comment					
Ditch within 10 feef from levee toe on LS.

View of a ditch near landside toe. Fall 2016.

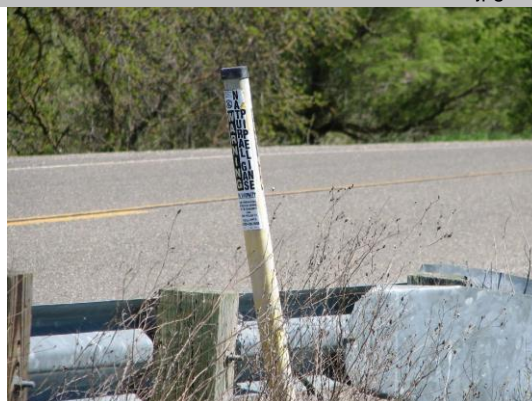
Photo 1 of 3 : UCIP_FA_2018_53017_18700.jpg

Comment Code					
Inspector Comment					
FS_ID:53017 DS_ID:19386 EP_NO: 13164 Repair Type: Non-Urgent Crossing Status: Indicator Found UCIP Comments: 09/16/2018 Crossing marker on levee Unit 02 is missing. Having a marker on County Road 16 shoulder is not enough to find exact crossing location on levee. Crossing has been downgraded to "Non-Urgent" due to reclassification of gas lines. (O.Yakimov - DWR)09/01/2016 - Markers present on the edges of Road 16. Alignment indicated by markers shows parallel alignment to the levee. Permit indicates pipe crosses levee and therefore should have markers indicating where it crosses the levee. (T. Hatch/UCIP)04/08/2013 - Need to have pipe located and marked properly if still in use. (W. Wylie/UCIP) FIELD_STRUCT_DESC: 4-inch steel natural gas collection pipe through the levee, 3.2 feet below the crown. Permit indicates that the pipe was installed on the northern shoulder of Road 16 and crosses the Knights Landing Ridge Cut on the northern side of the Road 16 bridge. (Permit No. 13164, 1981 - Shell Oil Company). FS Date: 10/16/2018 3:42:38 PM

Sign on LS shoulder may indicate location of pipe, or it may indicate where pipe crosses approach ramp to bridge.

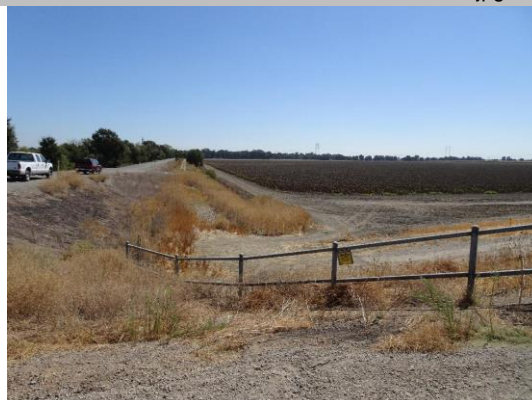
Photo 2 of 3 : UCIP_FA_2018_53017_75964.jpg

View from the levee crown looking toward the LS of the levee. gas line marker signs are visible marking an alignment parallel to the levee.

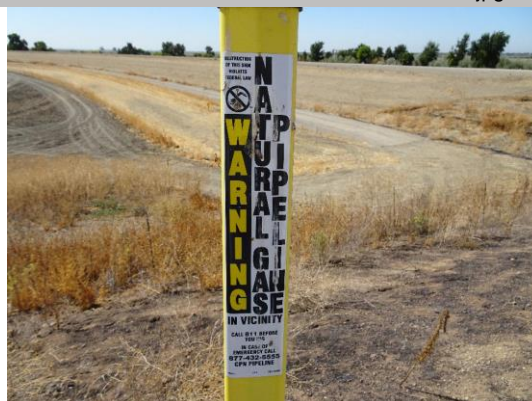
Photo 3 of 3 : UCIP_FA_2018_53017_75965.jpg

View of the marker signs information

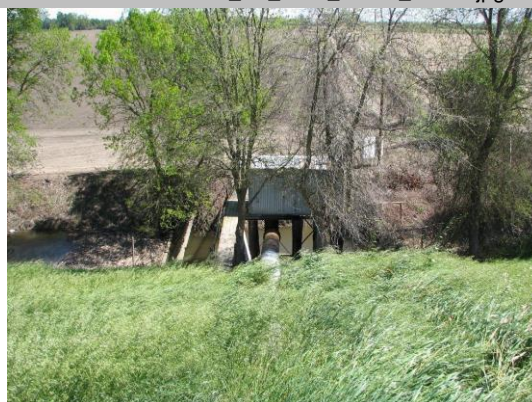
Photo 1 of 3 : UCIP_FA_2018_11291_18669.jpg

Pumphouse at LS toe.

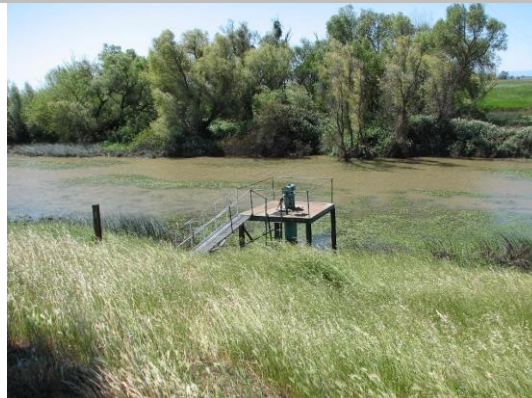
Photo 1 of 3 : UCIP_FA_2018_11289_18665.jpg

Comment Code					
Inspector Comment					
FS_ID:11289 DS_ID:19375 EP_NO: 3671 Repair Type: Non-Urgent Crossing Status: Found UCIP Comments: Electrical panal missing parts. Siphon breaker missing from pipe on LS. Pipe heavily corroded at outlet with holes present. Appears abandoned-should be abandoned properly. FIELD_STRUCT_DESC: 20-inch coated steel irrigation pipe through the levee, 5.5 feet below the crown. Siphon breaker in a steel pipe riser on the landside (LS) slope. Metal cutoff wall. Service pole on the waterside (WS) slope. (Replaced 20-inch pipe at same location in 1961 under Permit No. 3671, 1961 - Mary Anna Richardson). [Additional Reference(s): DWR Levee Log, 1990]. FS Date: 4/9/2013

Pump on pile structure on WS toe.
